# PROJECT COMPLETION REPORT

## OF THE REHABILITATION OF THE HERITAGE WOODEN ROOF OF THE CLOCK TOWER BY GAABESU

Indian Institute of Engineering Science and Technology (IEST), Shibpur  
Formerly Bengal Engineering College / B.E. College

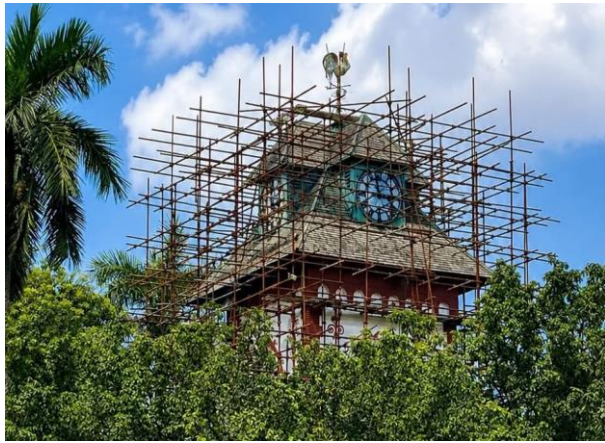
Inspection revealed deterioration associated with:

- prolonged exposure to moisture;
- rainwater ingress through deteriorated joints;
- decay and weathering of timber;
- possible fungal and biological attack;
- deterioration of individual timber planks;
- deterioration of weather-protective coatings; and
- localized gaps and defective joints which could permit further water penetration.

Photo-1 View before rehabilitation

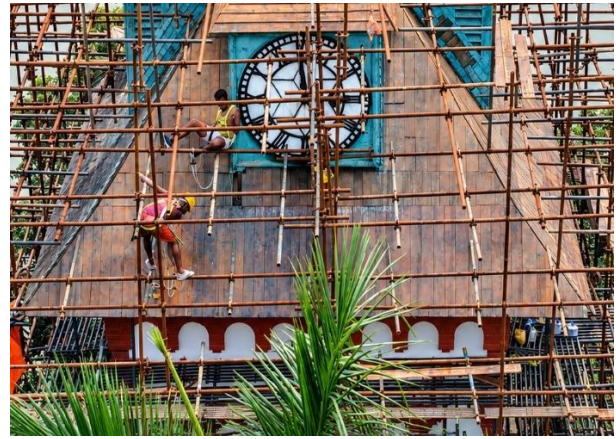
The exposed timber was then systematically inspected for:

- decay & fungal deterioration;
- termite and borer attack;
- moisture damage;
- splitting and cracking;
- loss of section;
- defective joints;
- mechanical damage; and
- other signs of distress.

Photo-2 Condition of 1<sup>st</sup> layer timber after removal of the upper layer timbers

Where deterioration was significant, the affected timber planks were carefully removed and replaced with **well-seasoned Shegun (teak) timber** of matching or compatible dimensions and profile.

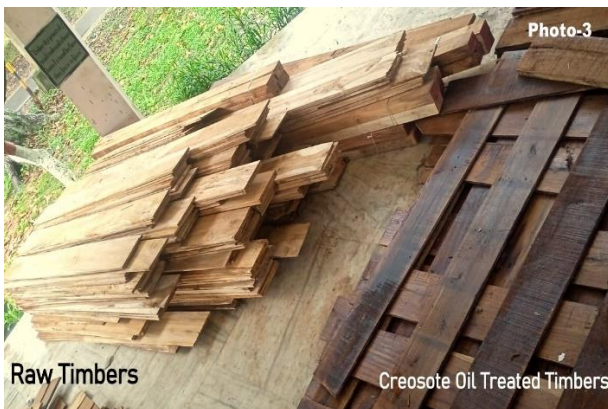
Photo-3 Creosote Oil Treatment of new timbers

The timber was initially treated with **Creosote Oil** to provide protection against biological deterioration, including termites, borers and fungal attack.

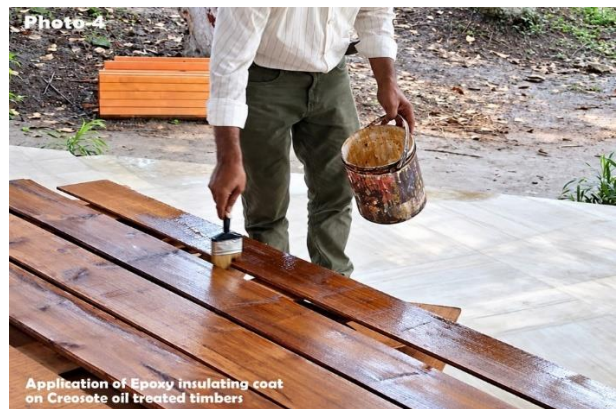
Photo-4 Application of Epoxy Insulation coat on creosote oil treated timbers

After drying, the timber surfaces received an additional protective coating using **Asian Paints WoodTech Epoxy Insulator**.

This epoxy-based insulating coat was adopted as an additional protective layer over and above the normal wood primer system, with the objective of improving resistance to moisture penetration and providing enhanced protection to the timber.

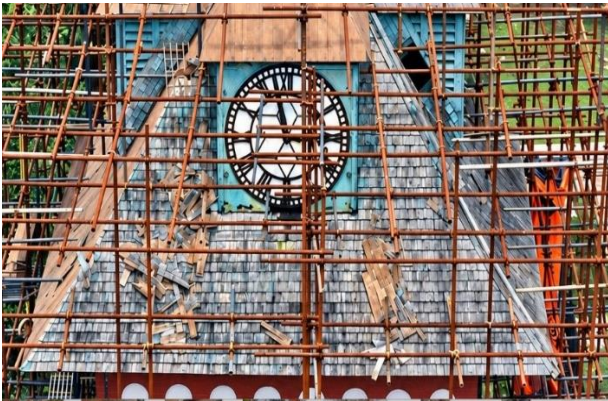
Photo-5 Entire top layer timbers being removed

Connection method of these timbers with the first layer was inspected and then entire timber planks from the upper layer was carefully removed to expose the underlying timber deck.

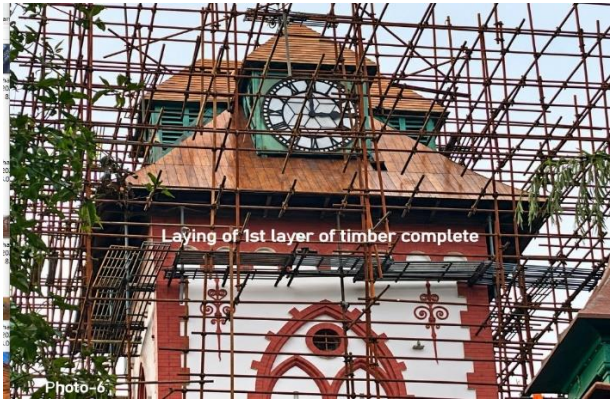
Photo-6 Completion of first layer timber fixing

After removal of the entire upper layer and the affected portions of the underlying timber deck, the flat timber decking was reconstructed by replacing worn-out, deteriorated or damaged timber planks with correctly sized seasoned timber.

The primary timber planks were laid **flat and edge-to-edge**, continuously over the supporting steel framework, to form the primary timber deck. Particular care was taken to ensure proper fitting and continuity of the joints.

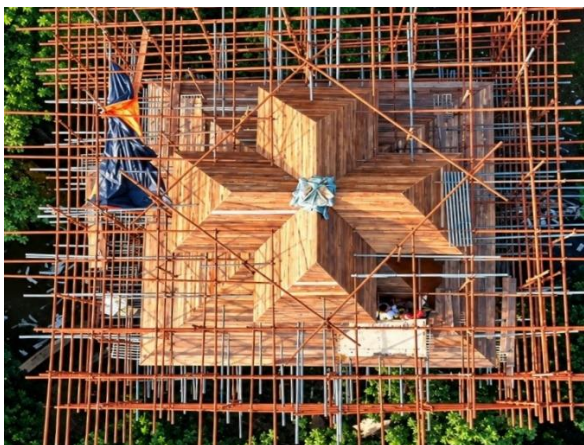
Photo-7 Installation of top layer timbers

After completion and inspection of the primary timber deck, the second layer of timber planks was installed.

Unlike the first layer, in which the planks were laid **flat and edge-to-edge**, the second layer was constructed as an **overlapping protective covering** over the primary deck. The adjoining timber planks were arranged so that their edges overlapped, thereby reducing the possibility of direct rainwater penetration through the joints.

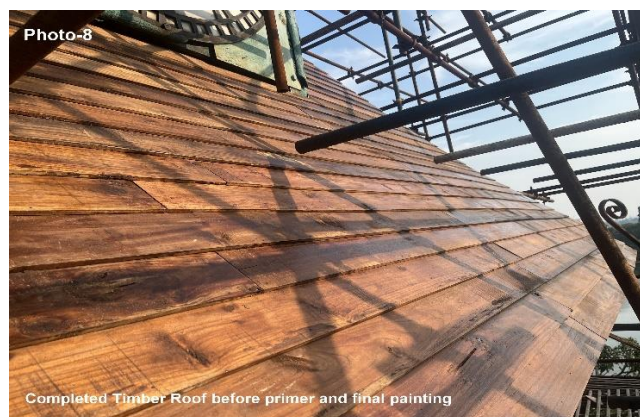
Photo-8 Completed timber roof before application of primer and final painting

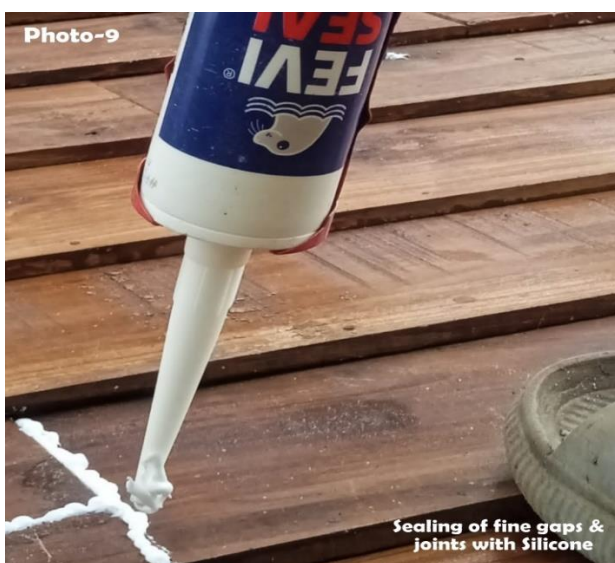
Photo-9 Sealing of fine gaps & joints with Silicone

Following completion of the timber decking and bonding works, the joints were thoroughly inspected. Where minor gaps or openings were observed, these were sealed to minimize the possibility of water penetration. For this purpose, **Feviseal / Dr. Fixit Silicone Sealant GPS Premium Acetoxy Cure (Clear)** was used at appropriate locations.

The sealing of these fine gaps was particularly important because even relatively small openings in an exposed heritage roof can permit repeated rainwater penetration over time. Before taking up the fixing of the second layers of timber planks, the entire surface was coated using Epoxy based Insulator undercoat.

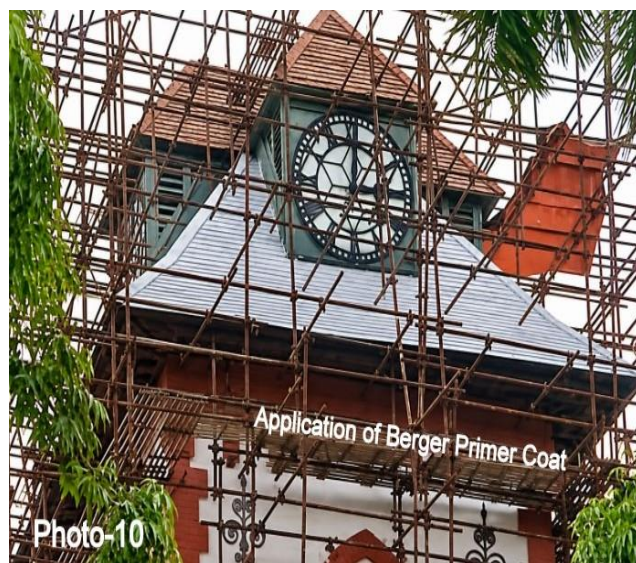
Photo-10 Application of Primer (undercoat)

Further another coat of epoxy-based insulating undercoat was applied to provide additional protection and to improve adhesion of the subsequent coating system.

The final finishing system comprised one coat of Berger Parrot Wood Primer and two coats of Berger Luxol Hi-Gloss Enamel Paint.

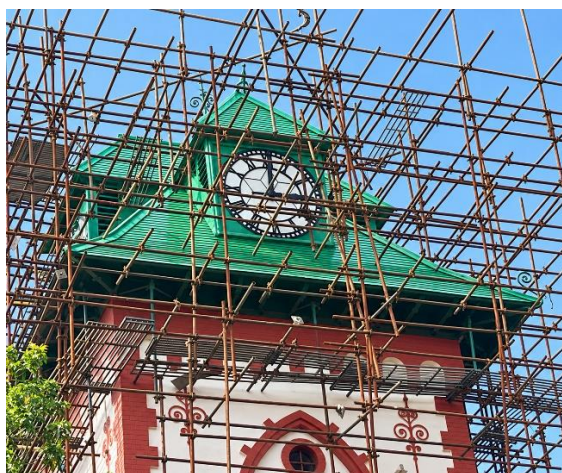
Photo-11 Application of Final Hi-Gloss Paint

The final exposed timber surfaces were finished with **two coats of Berger Luxol Hi-Gloss Enamel Paint**.

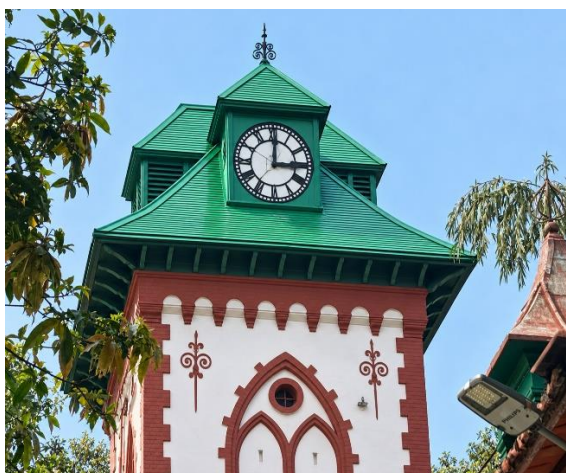
Photo-12 Completed View (Scaffoldings removed using AI)
